**Flood Control Project Maintenance
Levee Inspections**

Maintenance Issue Types Only, Levee Inspection Report By Mile - Spring 2017

Reclamation District No. 0536 Egbert

Waterway	Bank	Unit Miles	Inspection Start/End	Inspector
Unit No. 01 Lindsey Slough	Right	5.58	04/11/2017 04/11/2017	Herman Phillips

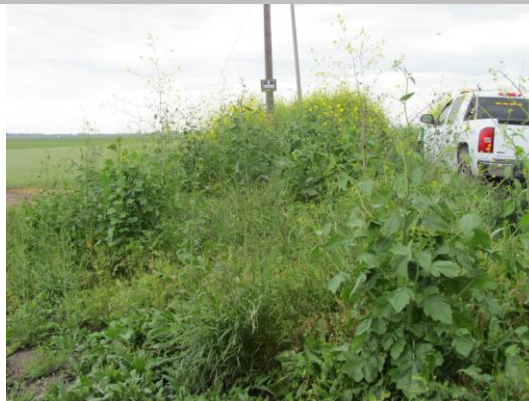
Photo 1 of 1 : SP_2017_RD0536_209_7_20170519_00016.jpg

LM Start	0.10	Rating **	U	Issue No.	7
LM End	4.38	Issue Type +	Ma	Location *	WS
Category	Earthen Levee			GPS Latitude/Longitude	
				Start	End
Item	Vegetation			38.244210 °	38.196720 °
				-121.696975 °	-121.699200 °
DWR ID	DWR_RD0536_02_s_2017_7				
Comment Code					
V1 : Control annual grass and weeds on the levee slopes and easements.					
Inspector Comment					
Remove the unsatisfactory wild growth of vegetation from the waterside slope and toe.
